Flight Motor Set 360H005 (STS-28R) Final Report

**Volume V
(Nozzle Component)**

September 1990

***Thiokol* CORPORATION
SPACE OPERATIONS**

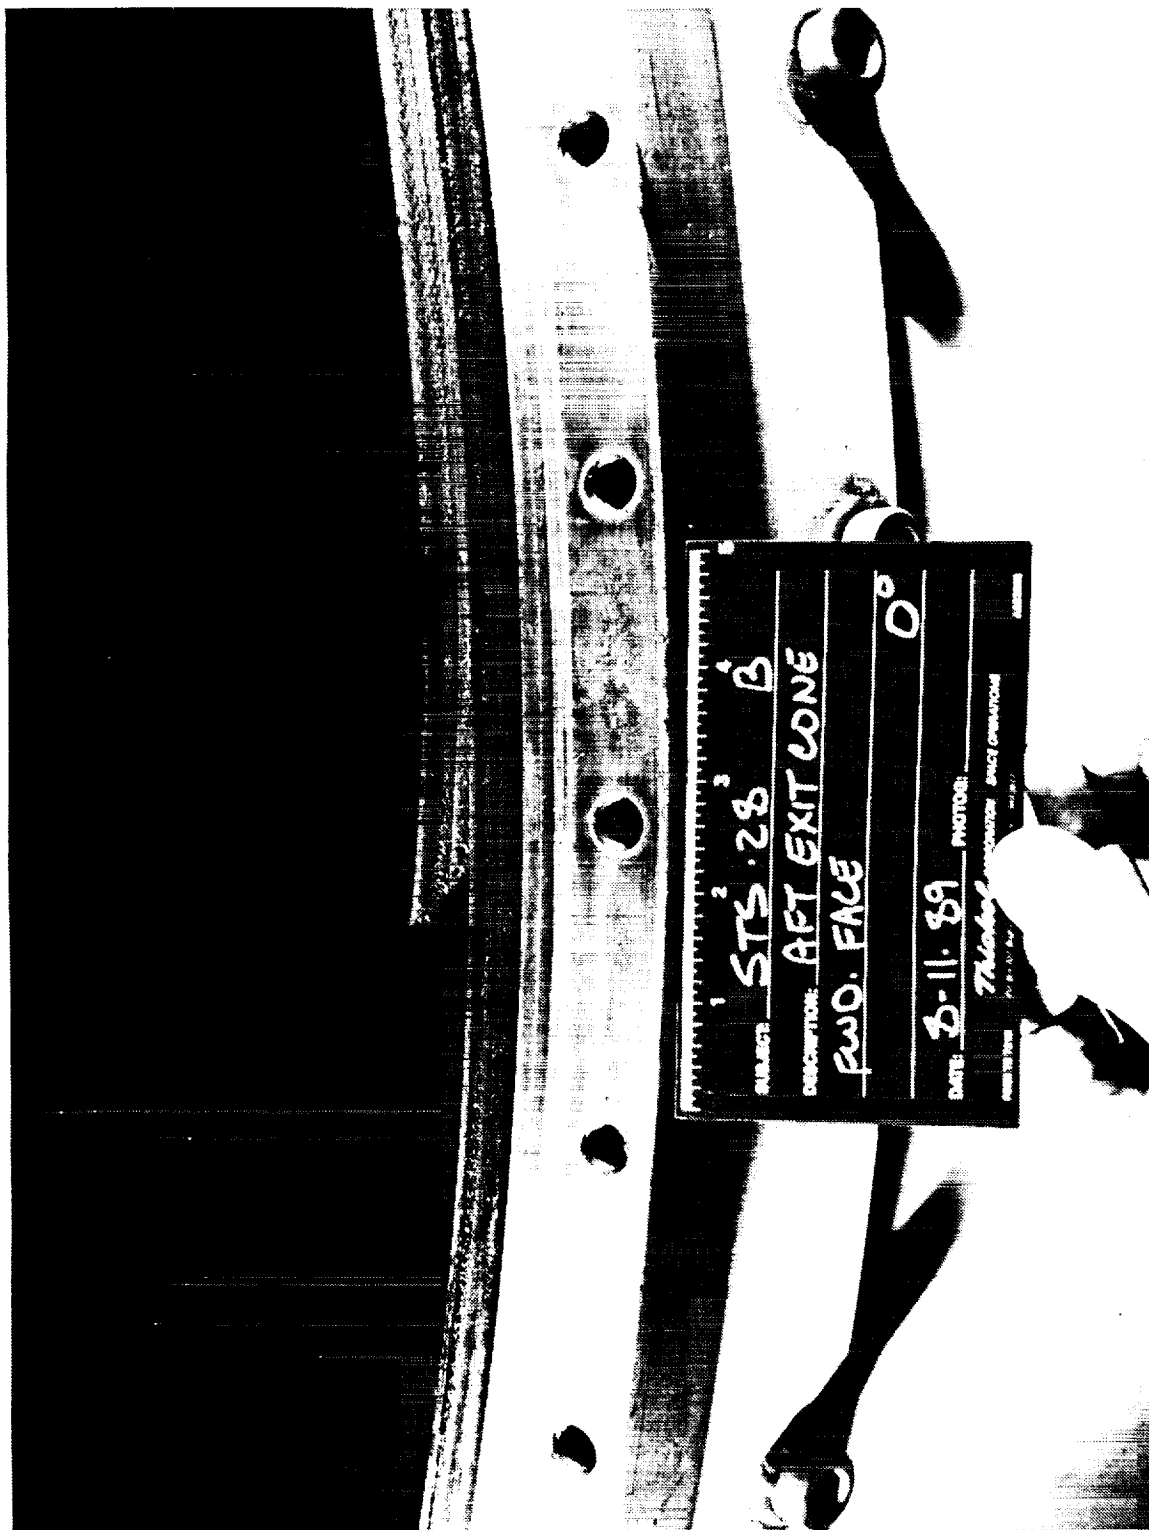
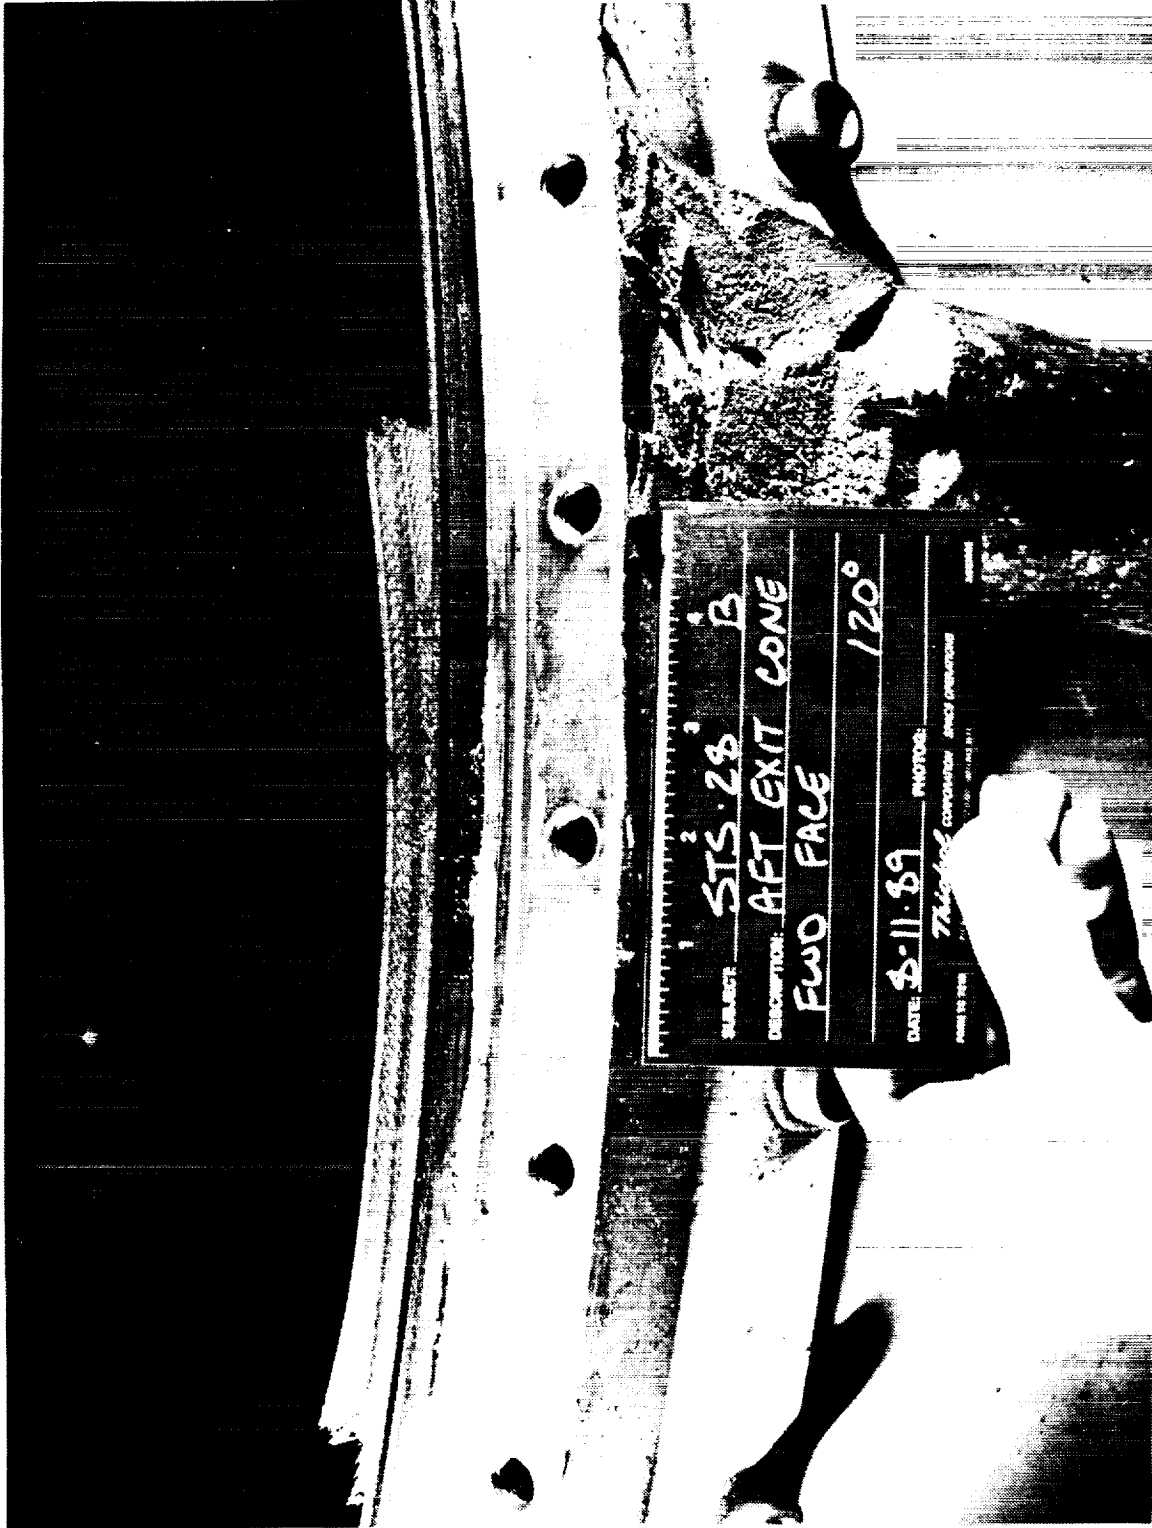
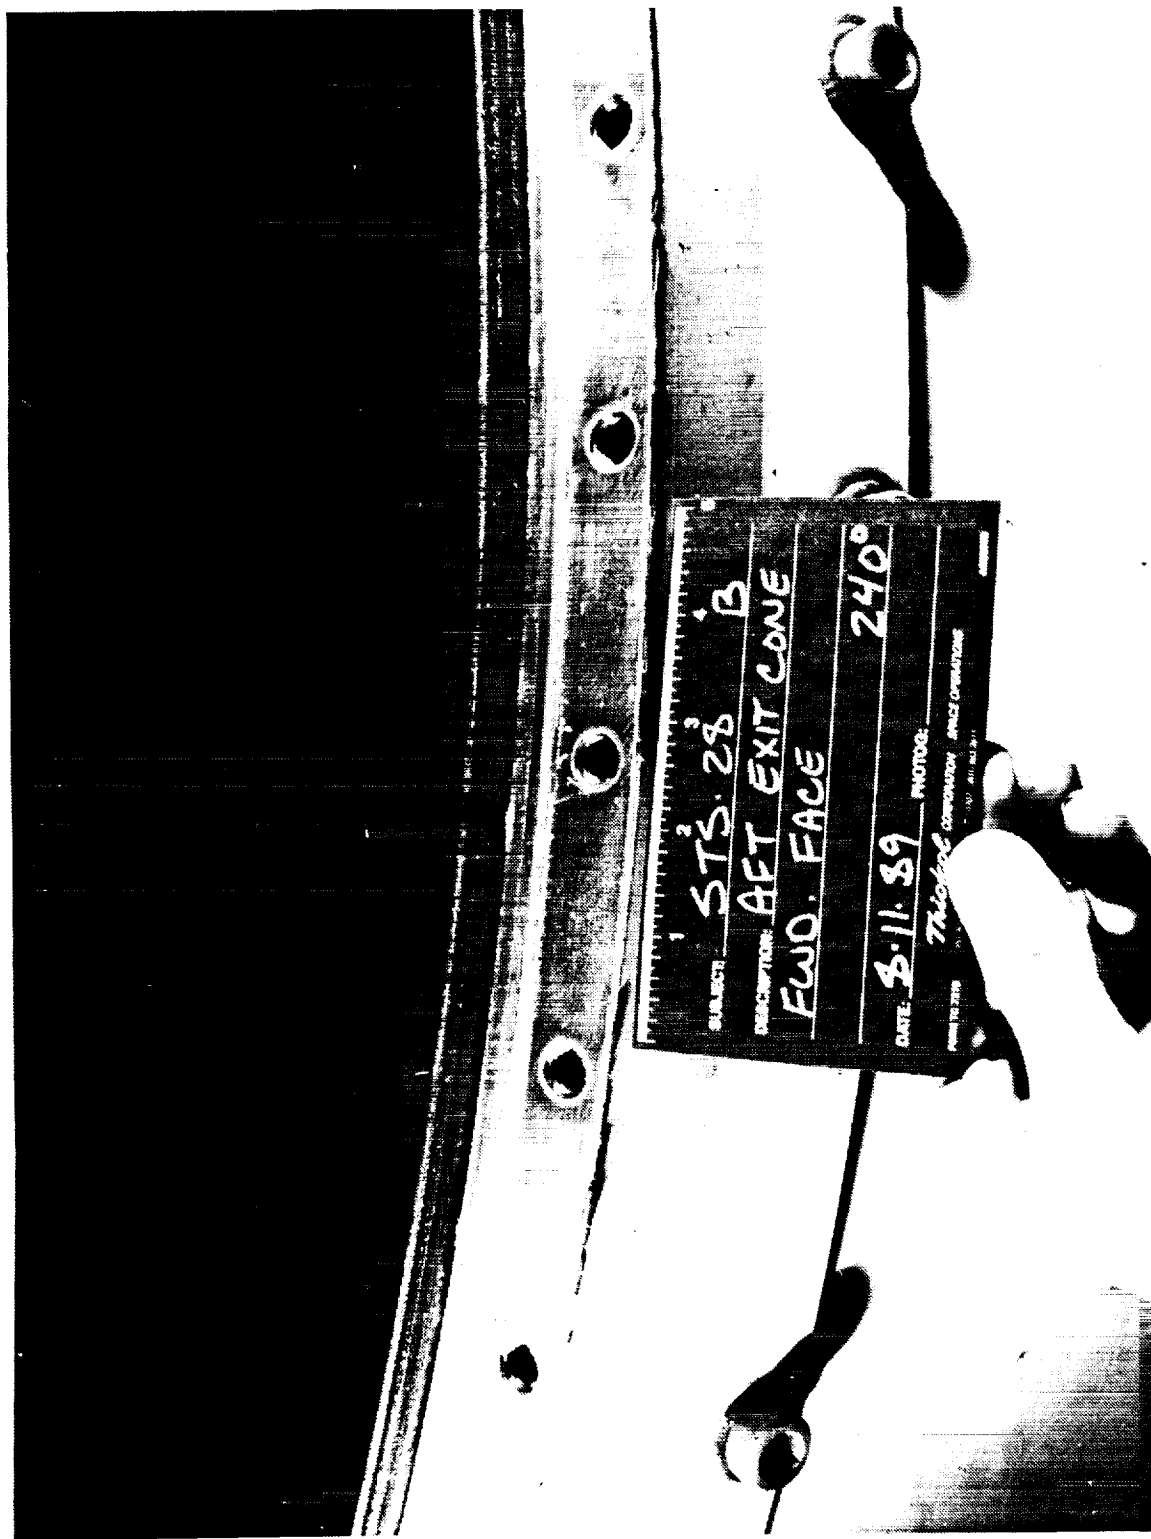
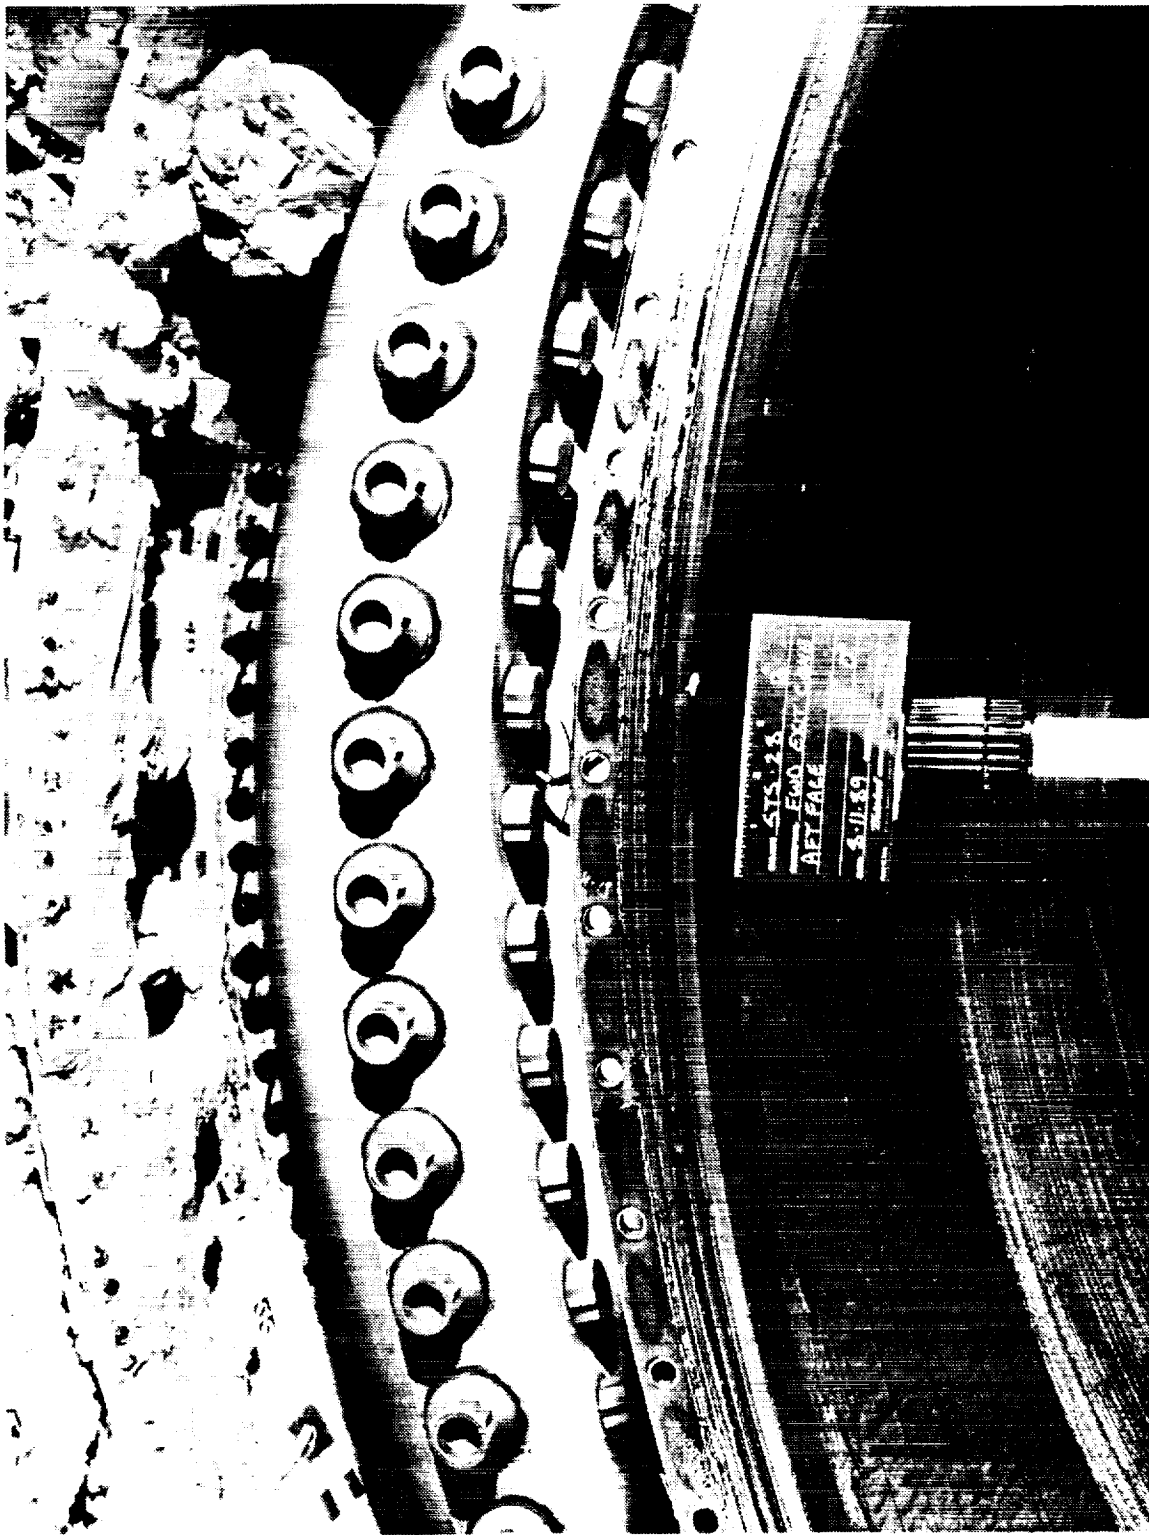
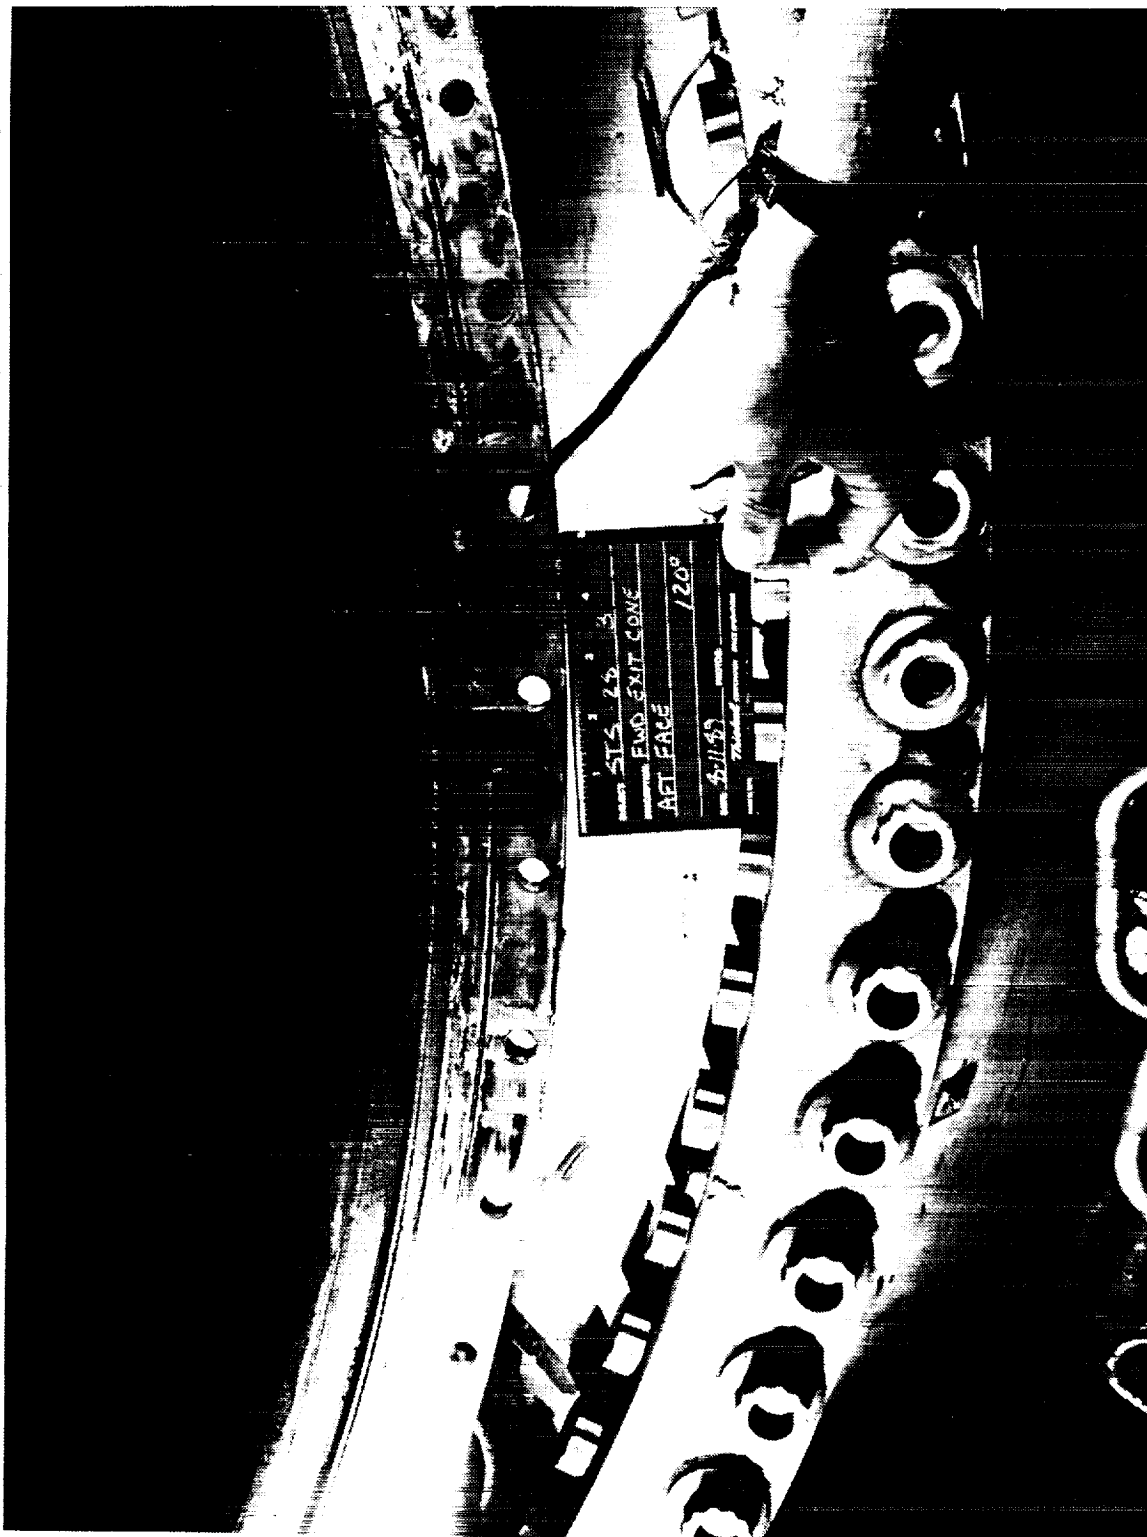
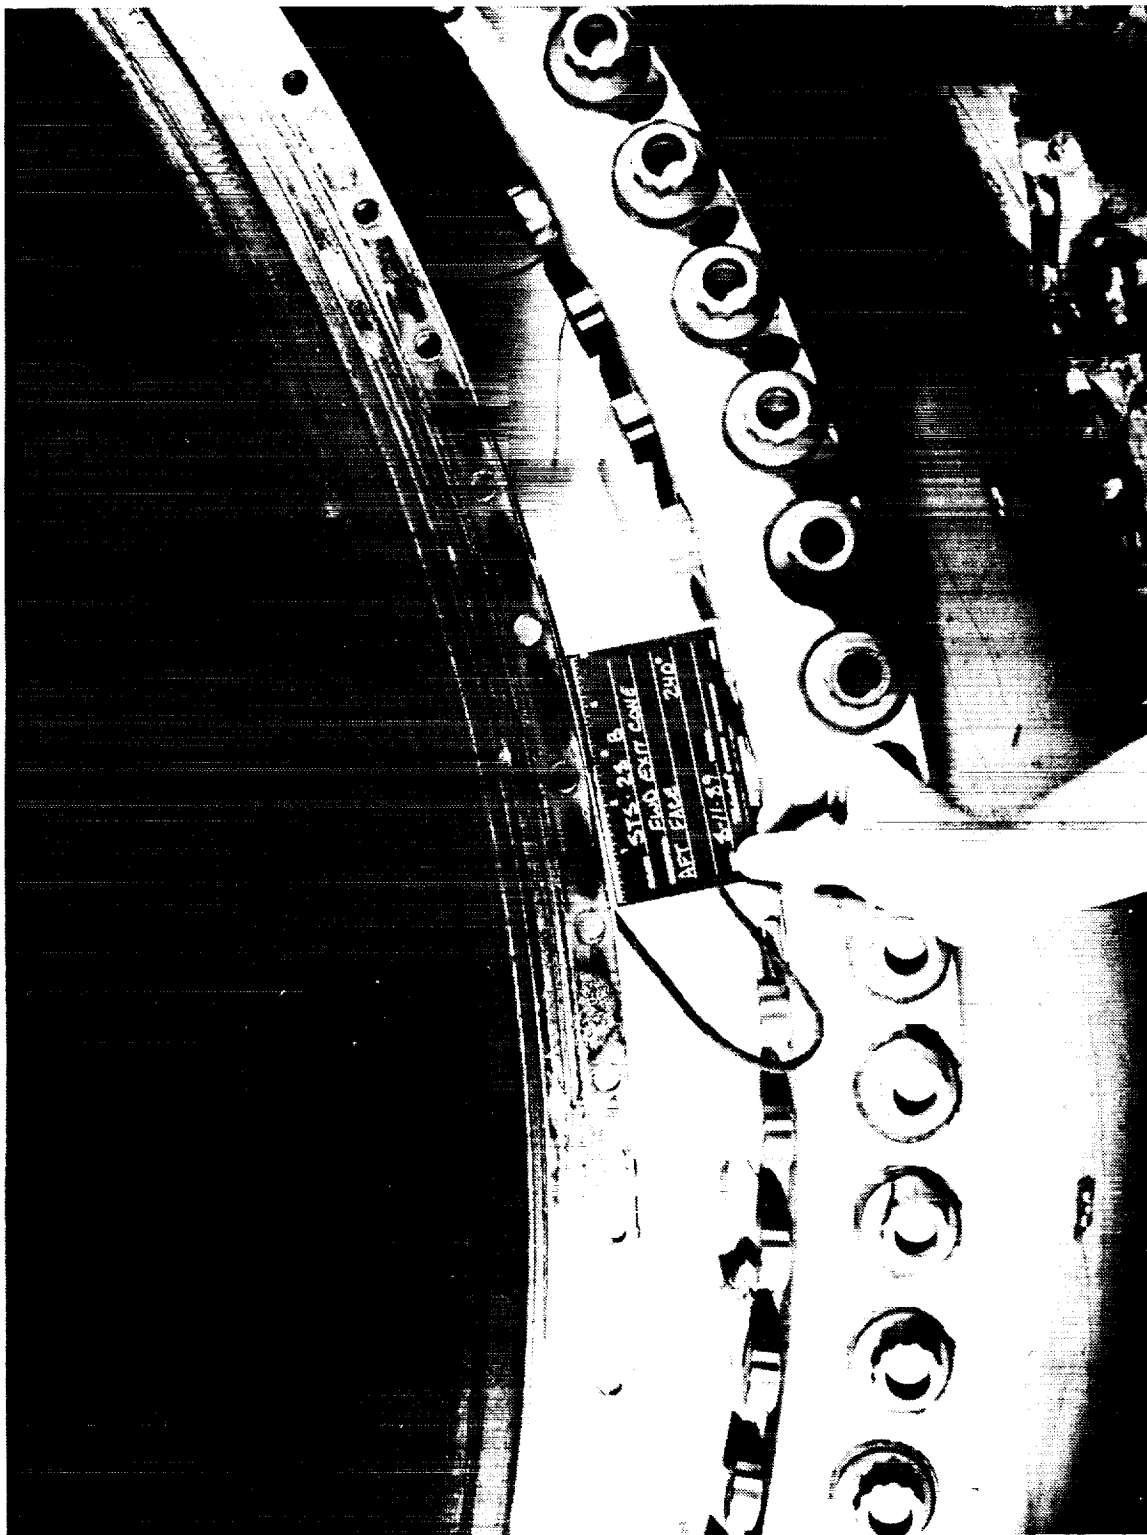
A cross-sectioned view of the STS-28B aft exit cone-to-forward exit cone field joint is presented in Figure 140. Photographs of the postflight joint are shown in Figures 141 through 146.

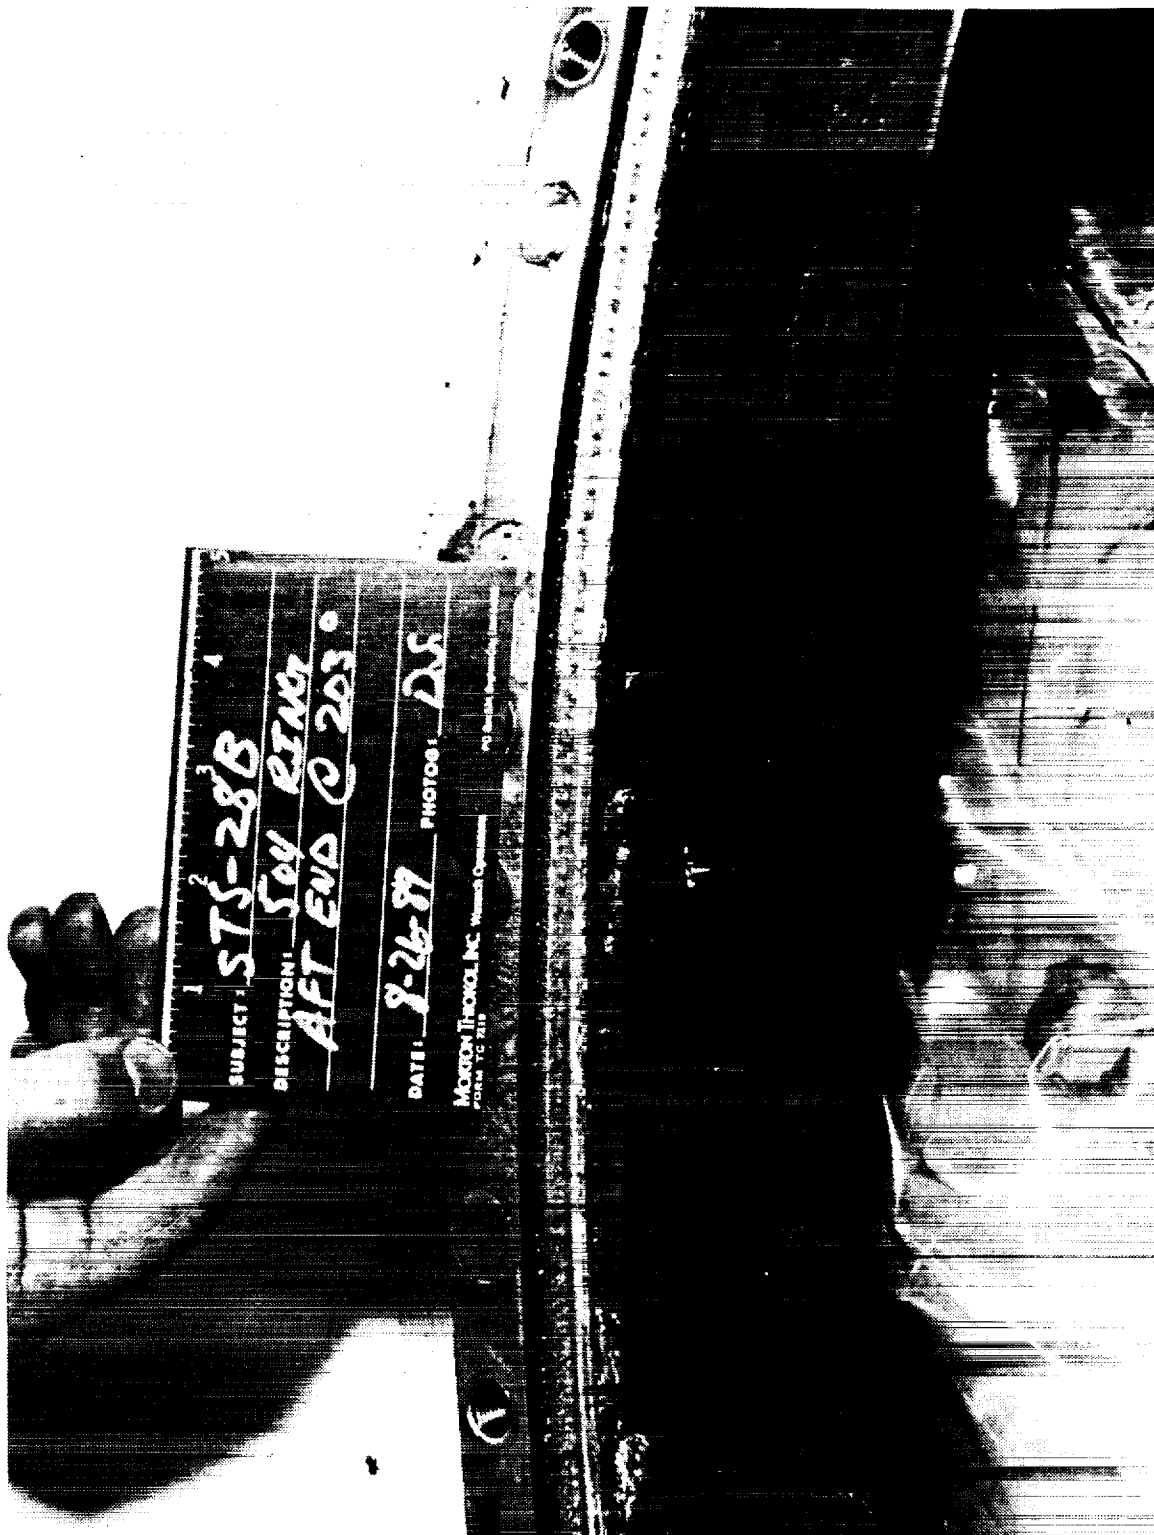
Figure 162 STS-28B Aft Inlet (-504) Ring - Aft End (203 deg)

Inspection of the radial OD portion of the joint showed a wet, black substance measuring approximately 2 inches circumferentially by 0.5 inch radially by 0.04 inch thick axially at 203 degrees (see Figure 162). This substance was located on the radial OD phenolic surfaces of the joint immediately behind the RTV backfill. Upon removal from the surface, it broke apart into a powdery form. The substance appeared fibrous.

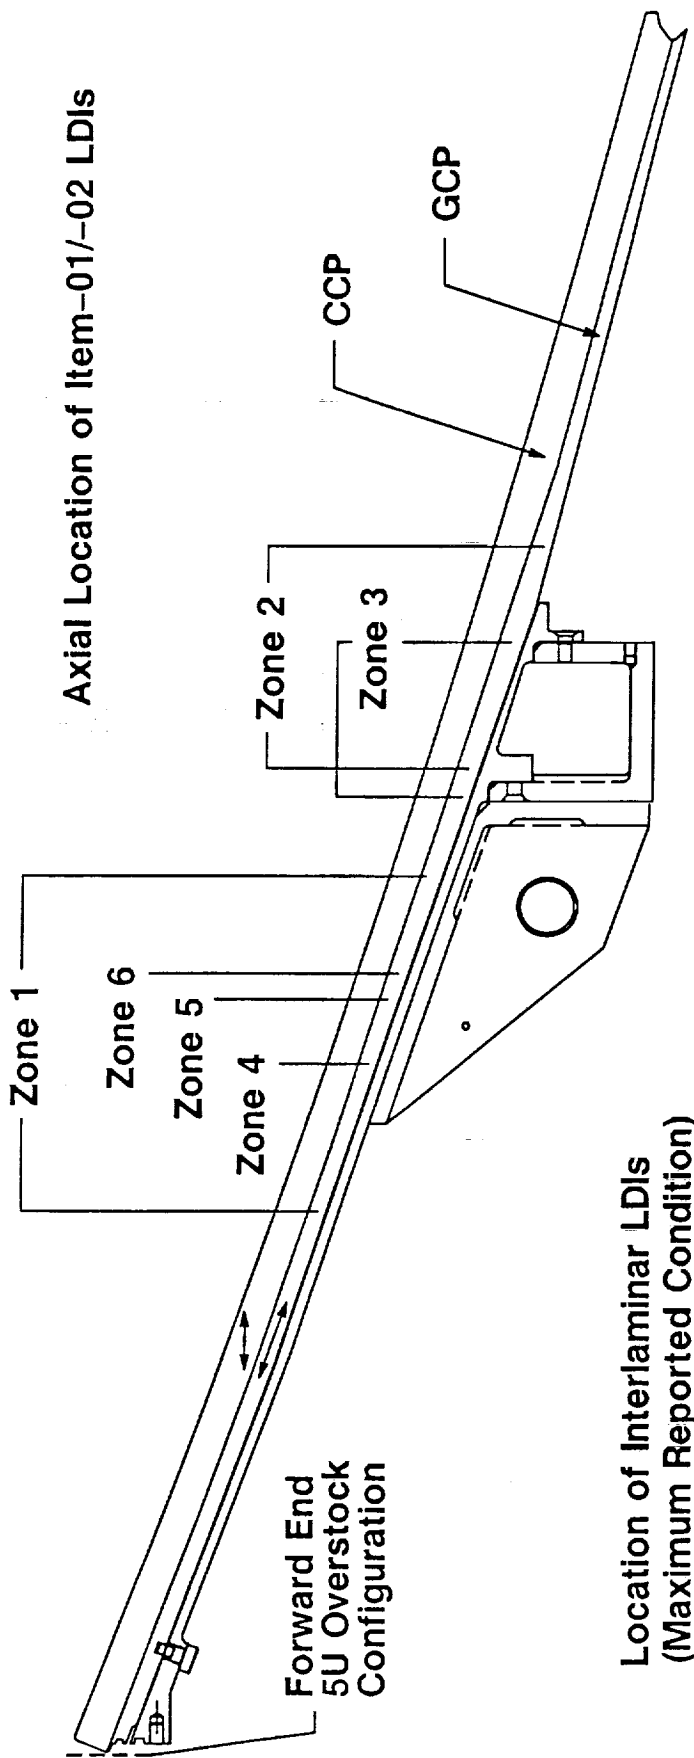
Location of Interlaminar LDIs
(Maximum Reported Condition)

Zone	Distance Aft of 5U Fwd End (in.)	Max Circum (in.)	Location (deg)	Max Long (in.)	Max Radial (in.)	No. of LDIs	Defect to Part OD (in.)
1	19.5-35.5	2.70	123	0.988	0.017	20	0.29
2	39.9-48.7	2.81	231	1.53	0.028	3	0.30
3	39.0-45.6	2.86	300	2.91	0.031	5	0.31
4	28.7	2.76	300	2.32	0.019	1	0.29
5	30.8	2.86	300	1.84	0.014	1	0.31
6	31.2	2.81	231	2.80	0.021	1	0.30

The design MMS for the aft exit cone GCP, including a 1.4 factor of safety, is 6.13 for interlaminar failure criteria (delamination) and 0.47 for in-plane failure criteria

The MMS for the LDI area is 20.63 for interlaminar failure criteria (delamination) and 3.25 for in-plane failure criteria

Interlaminar and ply-end LDI conditions have been seen on the PV-1 and 360L001A and B aft exit cone GCP insulators. All of these cones showed nominal performance

A change to the engineering acceptance criteria is being proposed. If approved, the revised criteria would accept the LDI conditions documented in this DR

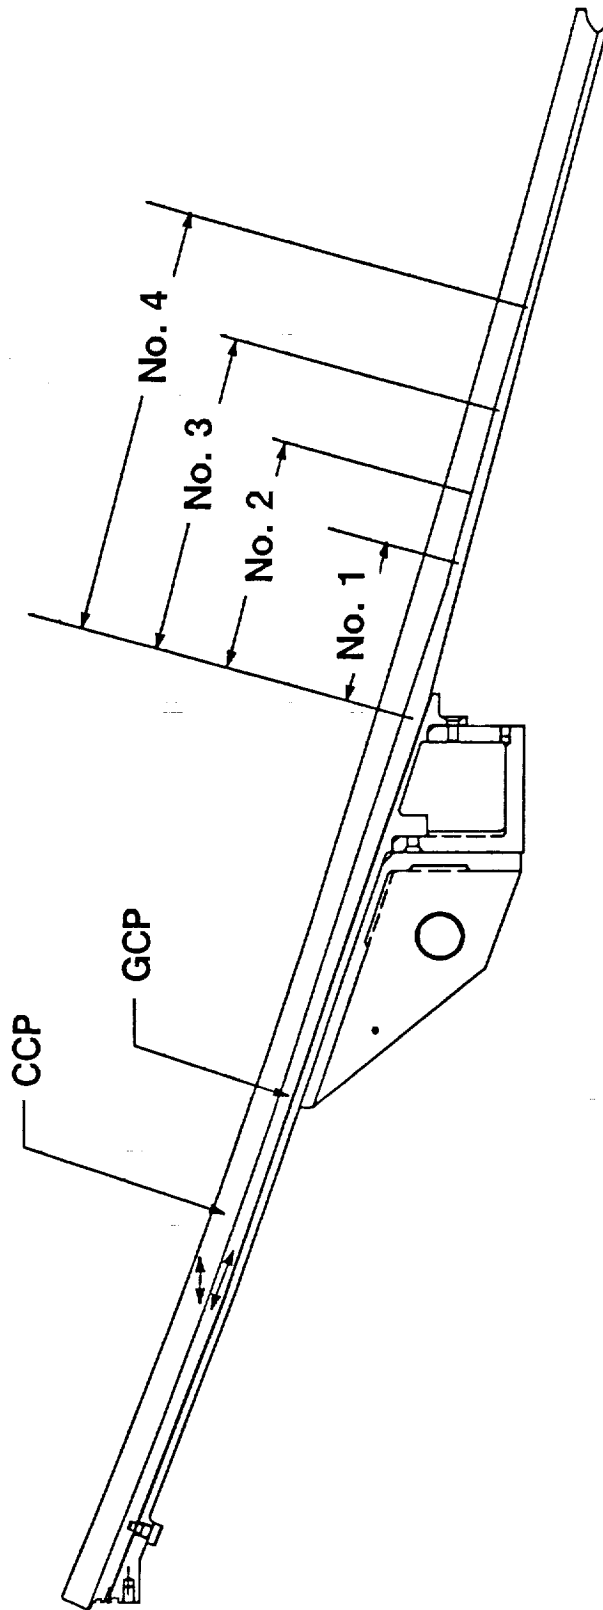
Location of Ply-End LDs Within
the GCP (maximum reported
condition)

Is: Four LDIs exceed one or more of the above dimensions (see sketch for size and location); all classified as ply-end conditions (longitudinal length <0.200 in.)

LDI No.	Distance Aft of Compliance Ring (in.)	Longitudinal Length (in.)	Radial Depth (in.)
1	8.19	0.092	0.031
2	11.57	0.029	0.027
3	15.90	0.048	0.027
4	21.36	0.068	0.027

The design MMS for the aft exit cone GCP, including a 1.4 factor of safety, is 6.13 for interlaminar failure criteria (delamination) and 0.47 for in-plane failure criteria

The MMS for the LDI areas is 97.6 for interlaminar failure criteria (delamination) and 0.82 for in-plane failure criteria (with 1.4 factor of safety)

Ply-end LDI conditions have been seen on the PV-1 and 360L001A and B aft exit cone GCP insulators. All of these cones showed nominal performance

A change to the engineering acceptance criteria is being proposed. If approved, the revised criteria would accept the LDI conditions documented in this DR

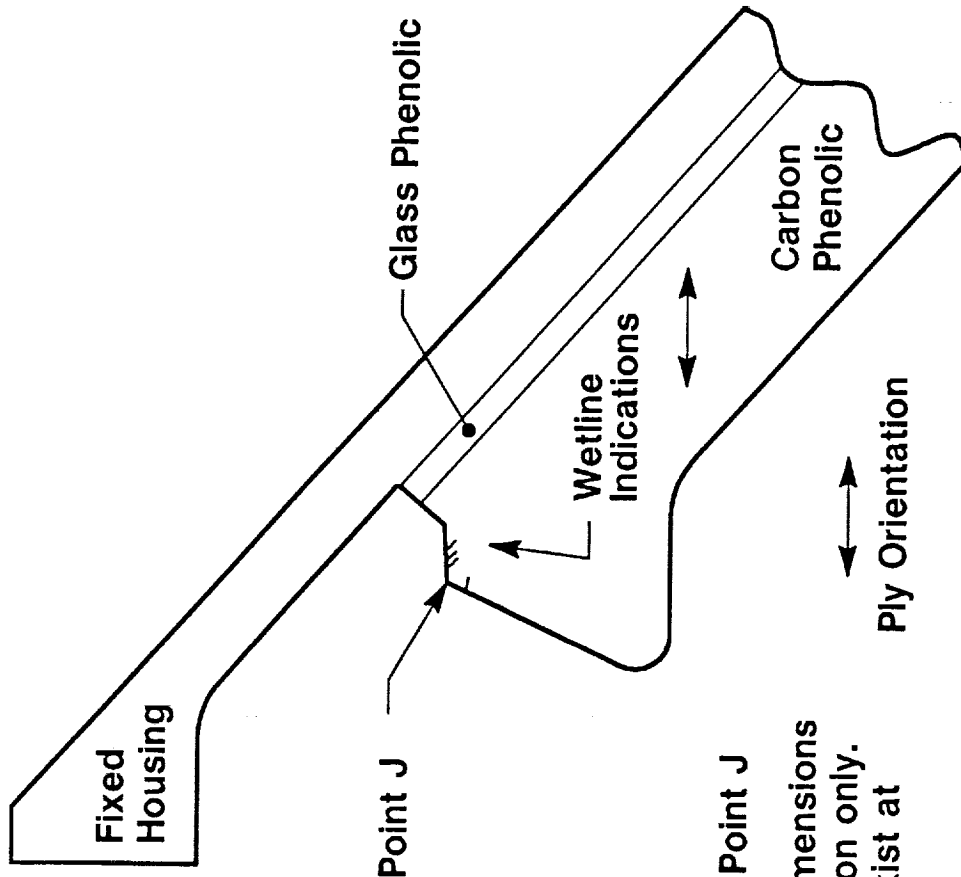
Is: Numerous wetline indications evident on carbon phenolic forward ID.
Maximum condition checks 13.5 in. circumferential length at 162 to 180 deg

Location (deg)	Circumferential Length (in.)	Radial Depth (in.)
141-150	3.000	Unknown
162-180	13.500	Unknown
200-205	2.300	Unknown
216-222	1.100	Unknown
265-272	4.200	Unknown

The wetline indications exist at Point J

Note: The above-mentioned dimensions are the maximum condition only. Other smaller wetlines exist at each noted deg location

Repair—Remove wetline indications by machining

Radiographic (X-ray) inspection revealed no subsurface LDIs or cracks

The noted wetline indications have been completely removed by machining

After repair, alcohol wipe inspection showed no surface anomalies remain
